Lower Thames Crossing – UXO Desk Study & Risk Assessment

Document Title UXO Desk Study & Risk Assessment
Document Ref. HE540039-ZET-GEN-GEN-REP-GEO-00001
Revision 3
Project Location Lower Thames Crossing
Client Arcadis
Date 31st August 2018

UXO DESK STUDY & RISK ASSESSMENT

Lower Thames Crossing

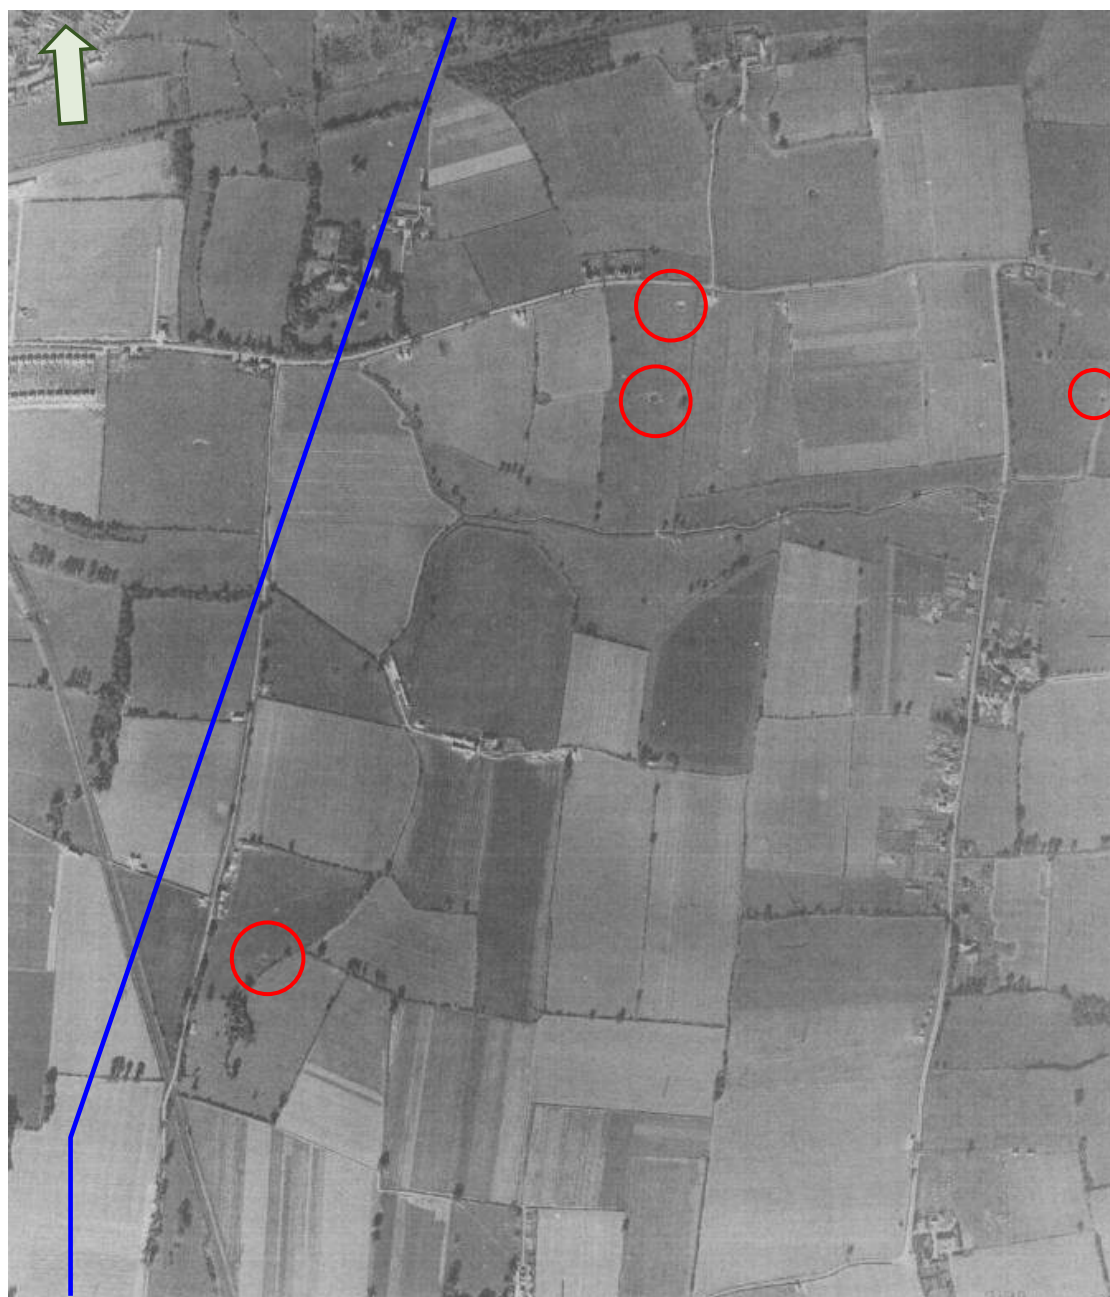
Plate 7 is an aerial photograph, dated the 11th October 1946, showing the Thames Chase area of the Site. Some possible bomb damage has been identified on the Site, although there is no evidence of any heavy cratering.

Aerial photograph, 11th October 1946 (Thames Chase)

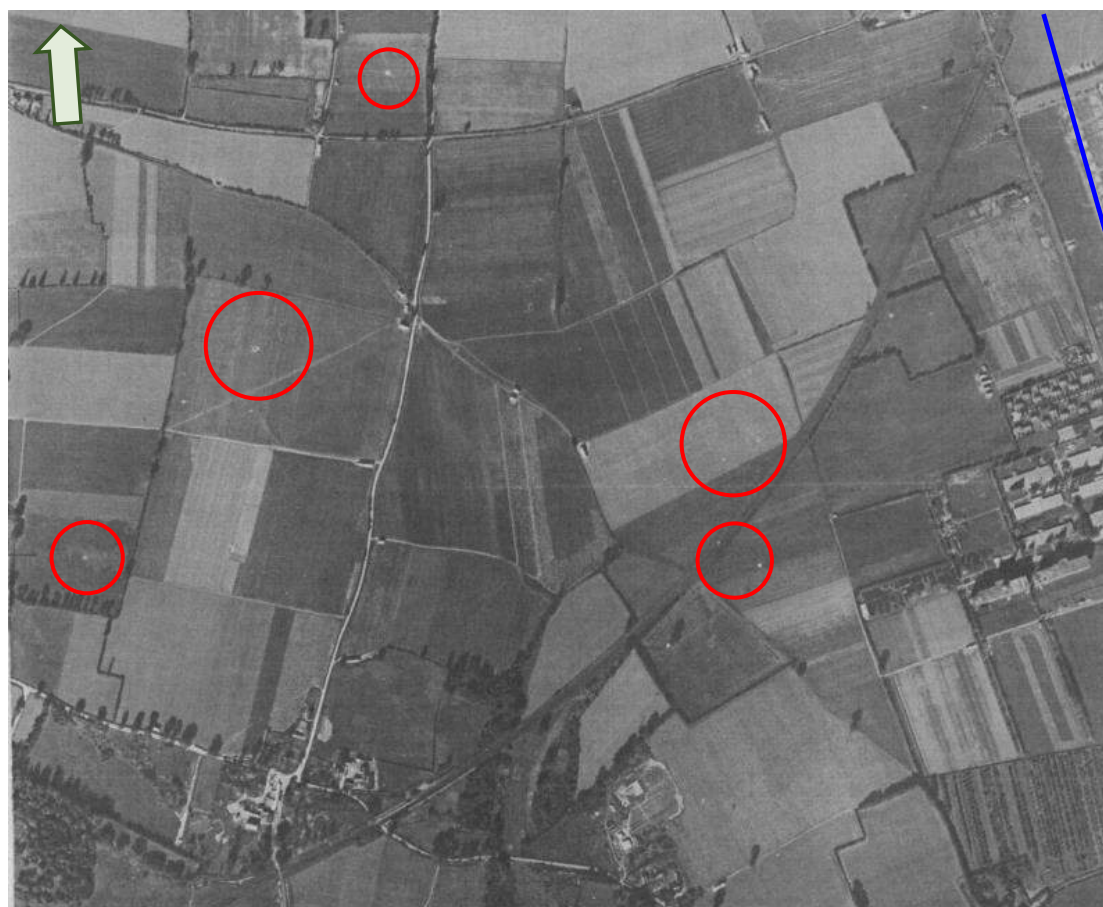
Plate 12

Plate 12, an aerial photograph dated the 11th October 1946, shows some areas of possible residual bomb damage on the Site at East Tilbury.

Aerial photograph, 11th October 1946 (East Tilbury)

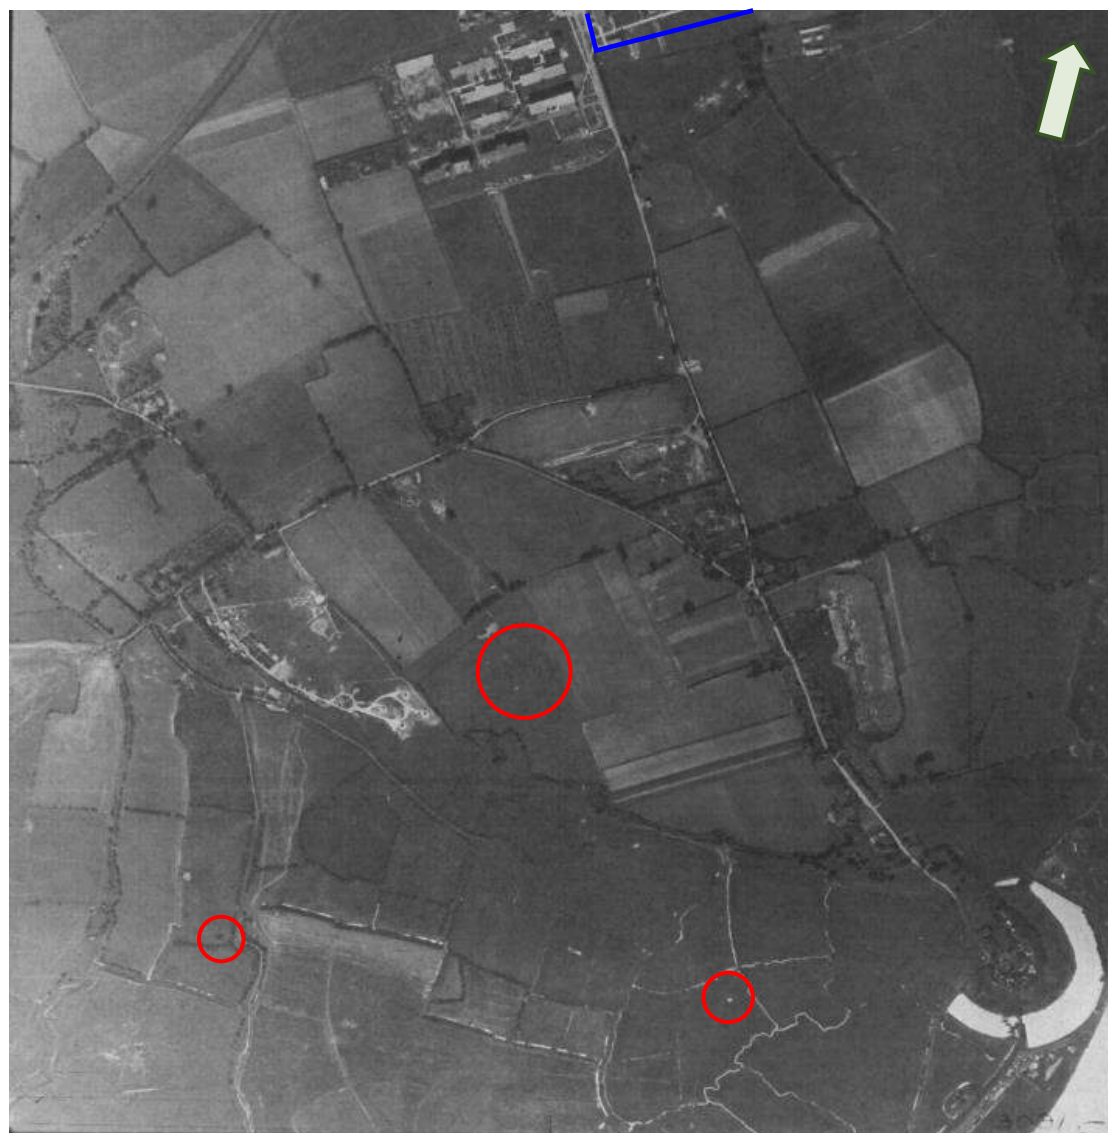
Plate 13

Plate 13, an aerial photograph dated the 1st May 1946, shows some possible infilled craters on the Site near Coalhouse Fort, East Tilbury.

Aerial photograph, 1st May 1946 (Coalhouse Fort)

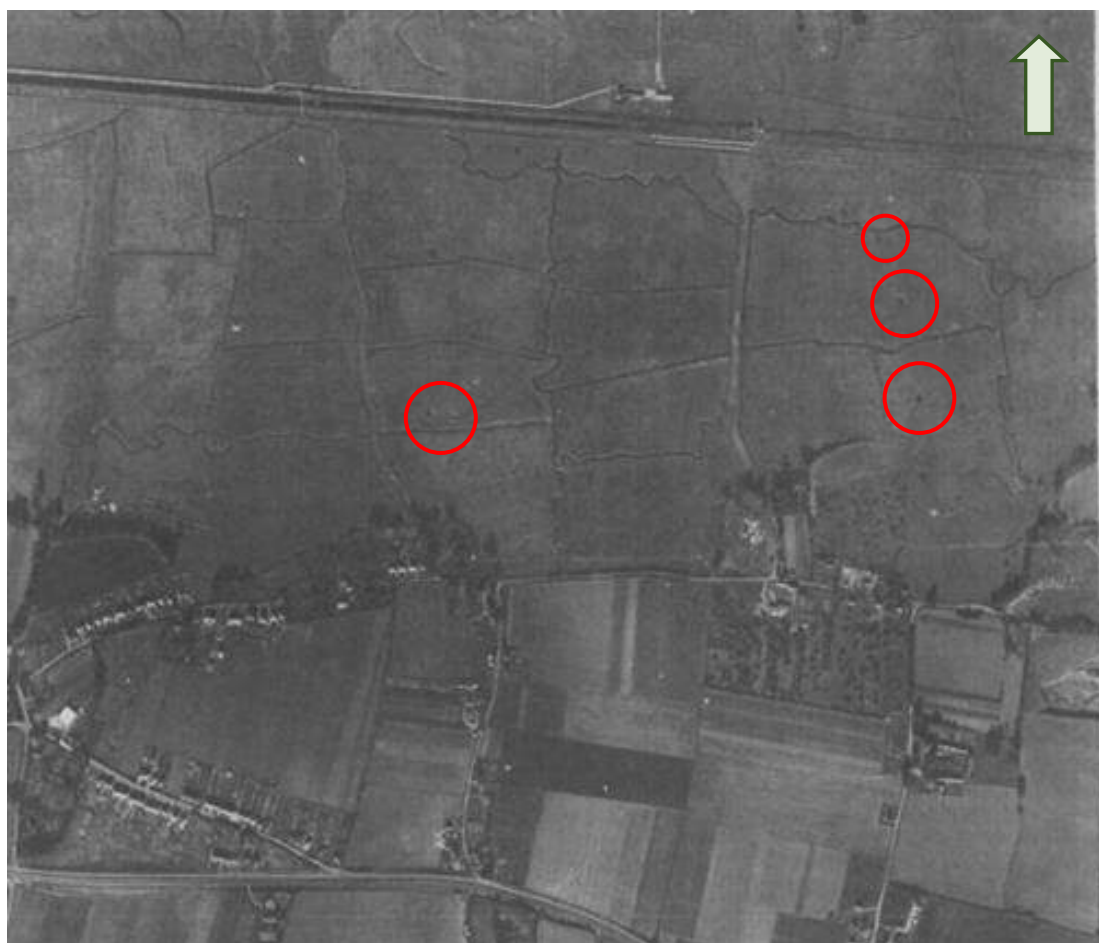
Plate 17 is an aerial photograph, dated the 11th October 1946, showing the Site at Filborough Marshes. Some possible isolated bomb craters have been identified on the Site.

Aerial photograph, 11th October 1946 (Filborough Marshes)

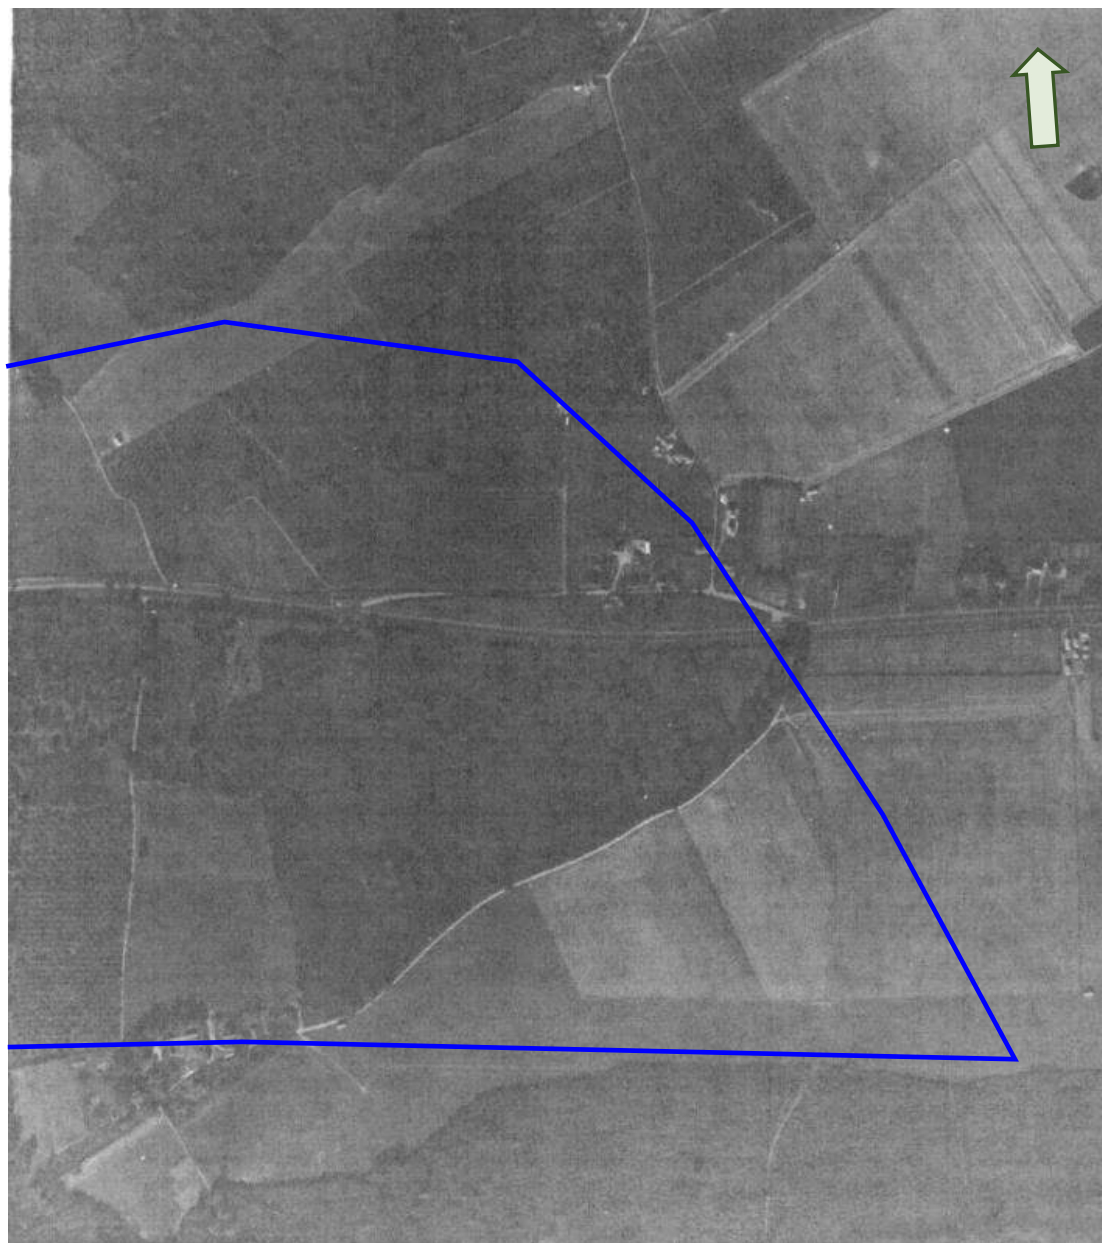
Plate 20 is an aerial photograph, dated the 11th October 1946, showing the Site to the south of Higham.

No bomb damage has been identified on this part of the Site.

Plate 20 Aerial photograph, 11th October 1946 (south of Higham)

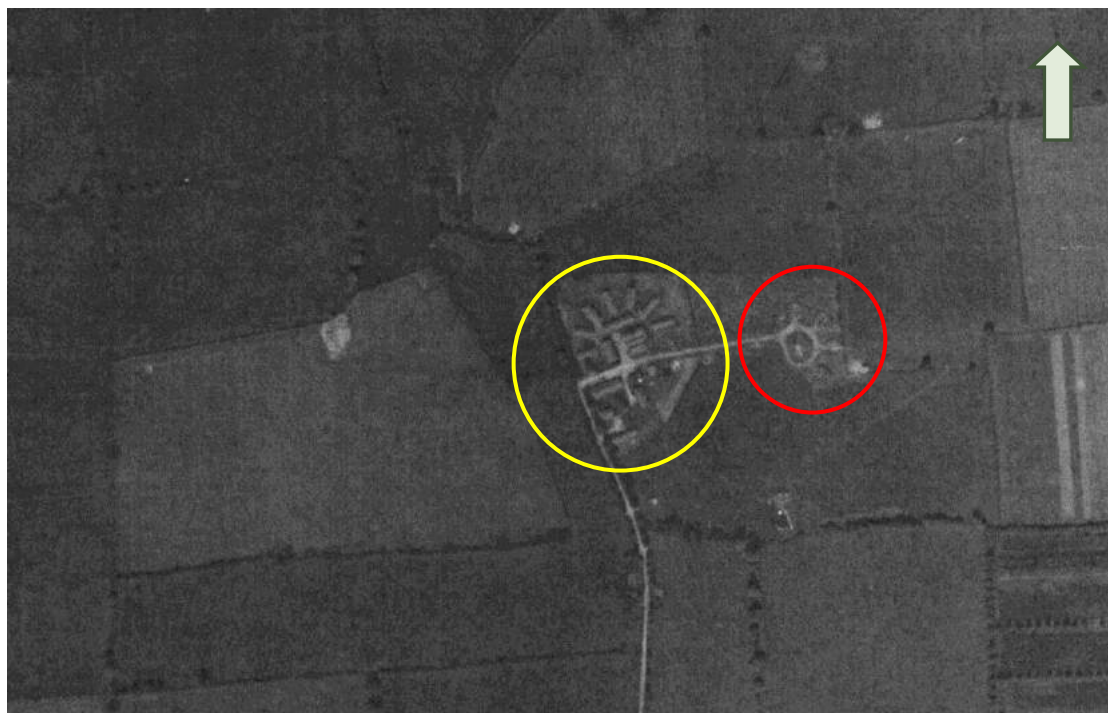
Plate 25	Aerial photograph showing HAA battery TN13, Orsett, 1 st May 1946

Source: Historic England		Not to Scale
Legend	HAA Battery ———	Accommodation and munitions stores ———
<p>Historical mapping indicates that the gun emplacements had been removed by 1960 but the remnants of the camp remained. These had also been removed by the 1970s. Part of the former camp area is occupied by housing and land occupied by the gun emplacements has been returned to agriculture.</p> <p>Munitions associated with the battery would typically have been removed at the end of WWII and returned to ordnance depots. The possibility that munitions were disposed of in the immediate vicinity of the battery cannot be totally discounted, although there is no evidence on aerial photographs of any potential disposal areas on the Site.</p>

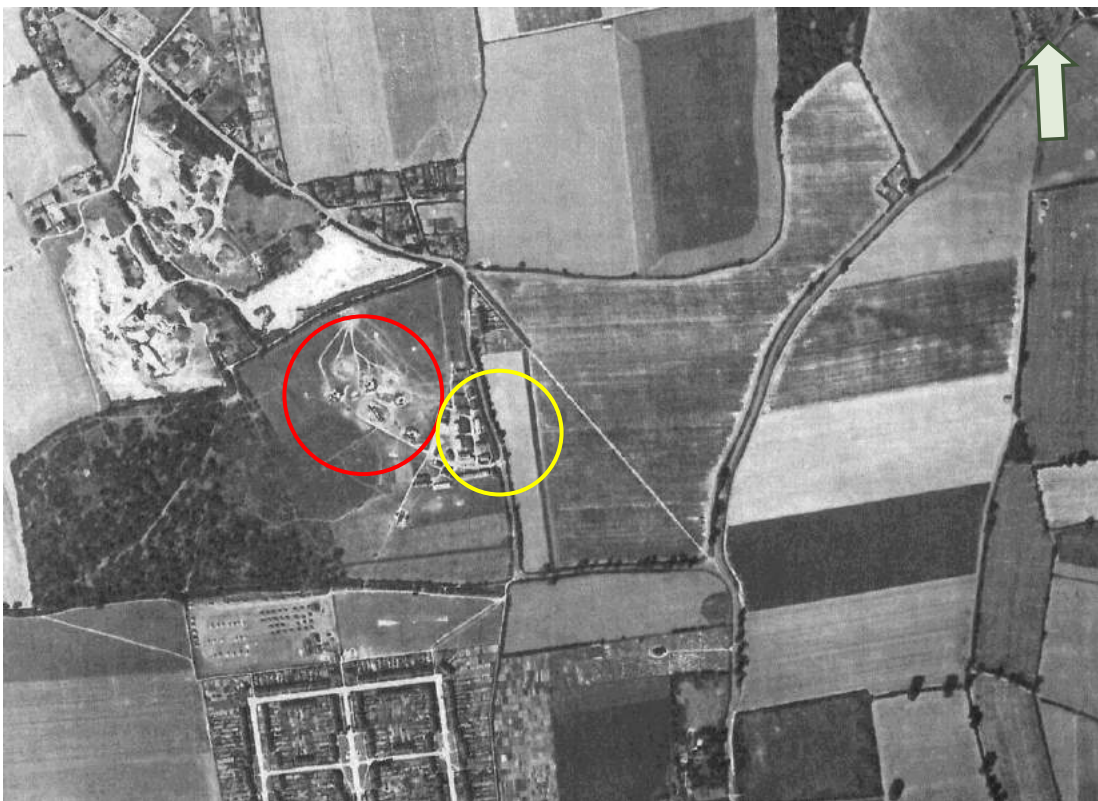
Plate 26	Aerial photograph showing HAA battery TN15, Chadwell, 4 th August 1944

4.2.3 HAA Battery TN15, Chadwell		
<p>1No. HAA battery was located on the Site at Chadwell (TQ 643796). It was armed with 4No. 4.5”guns and GL Mark II radar.</p> <p>Records indicate that it was manned by 8 Battery, 2nd Royal Artillery (RA) Regiment in 1942 and by 616 battery of the 184th (Mixed) RA Regiment in 1943.</p> <p>Typically, gun emplacements had inbuilt ammunition recesses and there was a control bunker (including command post, height finder and predictor) at the centre of the battery.</p> <p>Plate 26 is an aerial photograph, dated the 4th August 1944, showing HAA battery TN15, on the Site, with associated accommodation huts and munitions stores.</p>

Source: Historic England		Not to Scale
Legend	HAA Battery ———	Accommodation and munitions stores ———
<p>Post-WWII it was retained as an Off-Site Nucleus Battery. Historical mapping indicates that the land occupied by the gun site and camp had been mostly redeveloped for housing by the 1960s.</p> <p>Munitions associated with the battery would typically have been removed at the end of the war and returned to ordnance depots. The possibility that munitions were disposed of in the immediate vicinity of the battery cannot be totally discounted, although there is no evidence on aerial photographs of any potential disposal areas on the Site.</p>

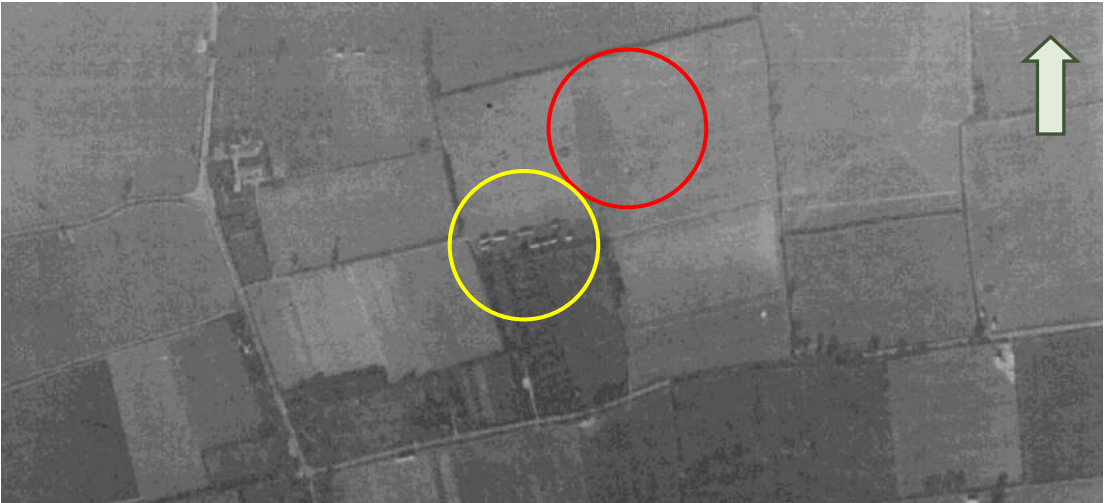
Plate 27	Aerial photograph showing HAA battery TN17, North Ockendon, 11 th October 1946

4.2.4 HAA Battery TN17, North Ockendon		
<p>1No. HAA battery is recorded on the Site at north of Fen Lane, North Ockendon (TQ 599856). It is recorded as being unarmed in 1942.</p> <p>Typically, gun emplacements had inbuilt ammunition recesses and there was a control bunker (including command post, height finder and predictor) at the centre of the battery.</p> <p>Plate 27 is an aerial photograph, dated the 11th October 1946, showing site of HAA battery TN17 and associated camp, on the Site.</p> <p>No permanent gun emplacements appear to have been constructed for this HAA site and only faint remnants of their position are visible on the photograph. The camp is still present.</p>

Source: Historic England		Not to Scale
Legend	HAA Battery ———	Accommodation and munitions stores ———
<p>There is no evidence of the gun site or camp on post-WWII mapping and the land is currently under cultivation.</p> <p>Munitions associated with the battery would typically have been removed at the end of the war and returned to ordnance depots. The possibility that munitions were disposed of in the immediate vicinity of the battery cannot be totally discounted, although there is no evidence on aerial photographs of any potential disposal areas on the Site.</p>		
Potential UXO Hazard		
<p>HAA batteries typically had associated munitions caches and stores. These stores were typically removed once the threat of invasion had passed, although the possibility that localised disposal occurred cannot be totally discounted.</p> <p>This forms part of the low background risk for any similar site in the UK.</p> <p>There is no positive evidence to indicate that such disposal took place on the Site and therefore HAA battery TN17 is not considered to provide a significant source of UXO hazard to the Site.</p>

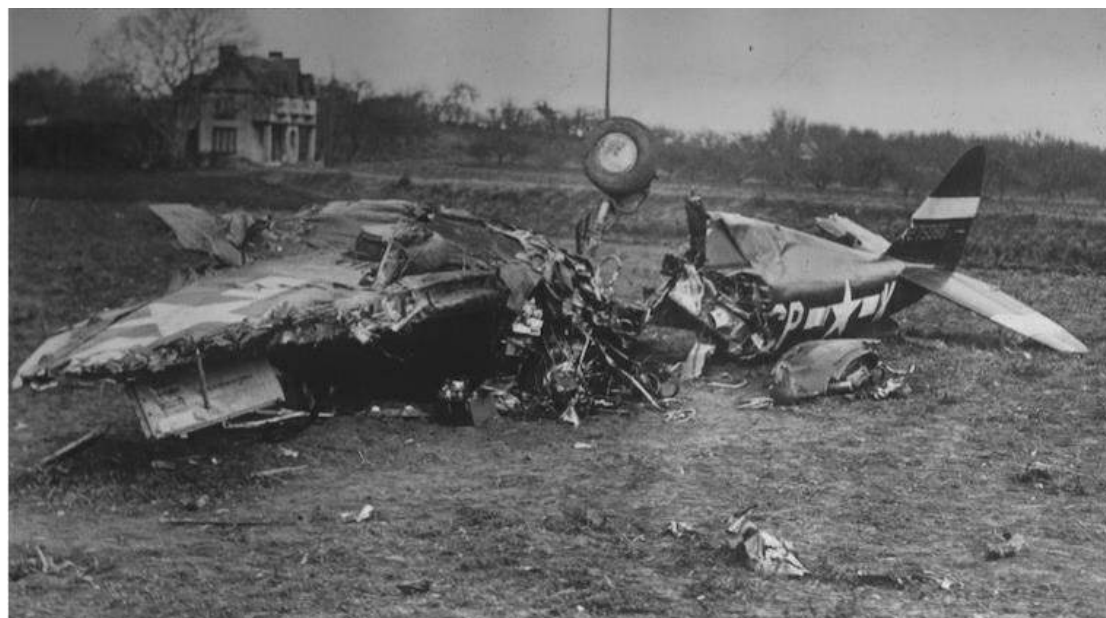
Plate 32 is a photograph showing the crash site, demonstrating a fighter aircraft wreckage that can lead to the spread of both debris and SAA over a wide area.

Photograph of the crash site of Republic Thunderbolt (42-75080), 1943

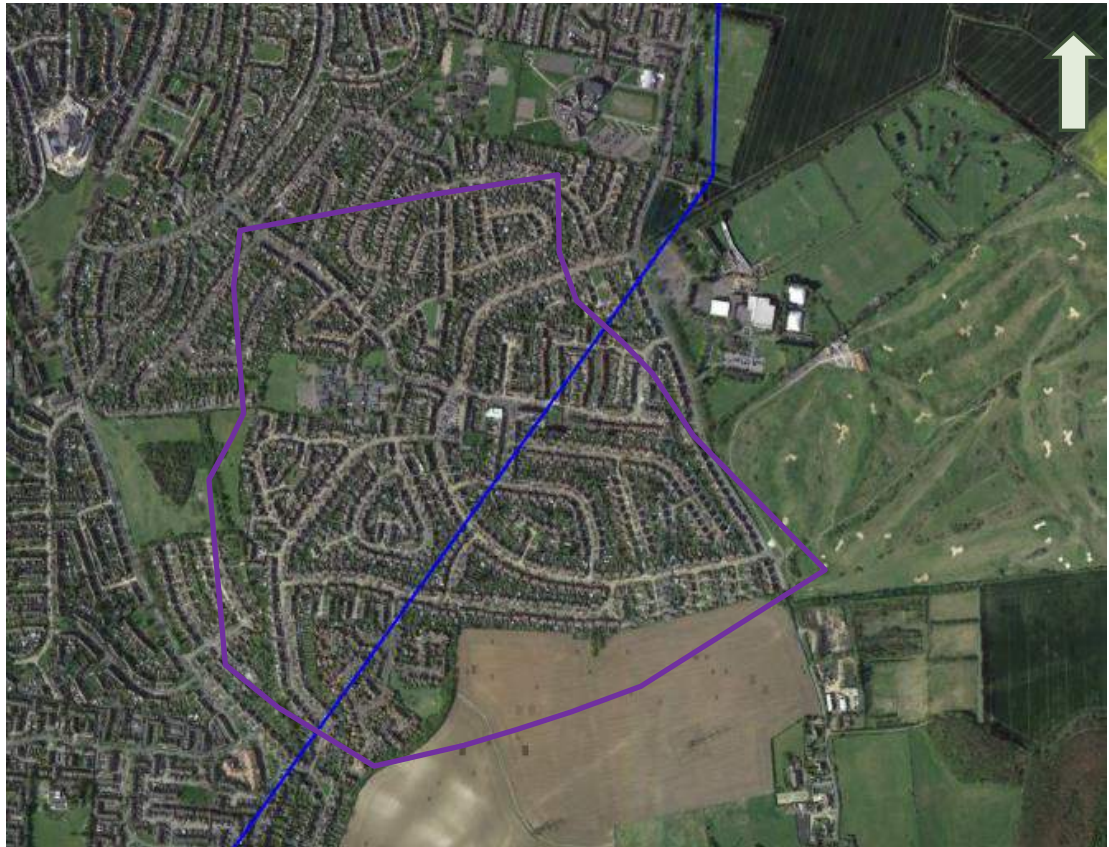
Plate 35	Recent aerial photograph showing the Site in relation to the original boundary of RAF Gravesend

Source: Google Earth Not to Scale		
Legend	Site boundary —	Airfield boundary —
Potential UXO Hazard		
<p>The part of the Site likely to have been pipe mined has since been redeveloped for housing. It is possible that any remaining mines were removed during this development, although no records have been found to confirm this.</p> <p>It should also be noted that pipe mines on airfields could be laid at depths up to 5.0m, beyond the typical detection capabilities of geophysical instruments of the time, and also potentially below post-WWII housing foundations.</p> <p>Therefore if intrusive works are to take place in this area, it is considered prudent to undertake proactive risk mitigation to ensure that any residual risk from pipe mines is suitably mitigated.</p> <p>This area is identified as M4 in Figure 27, and shown on HE540039-ZET-GEN-GEN-MAP-GEO-00001.</p>

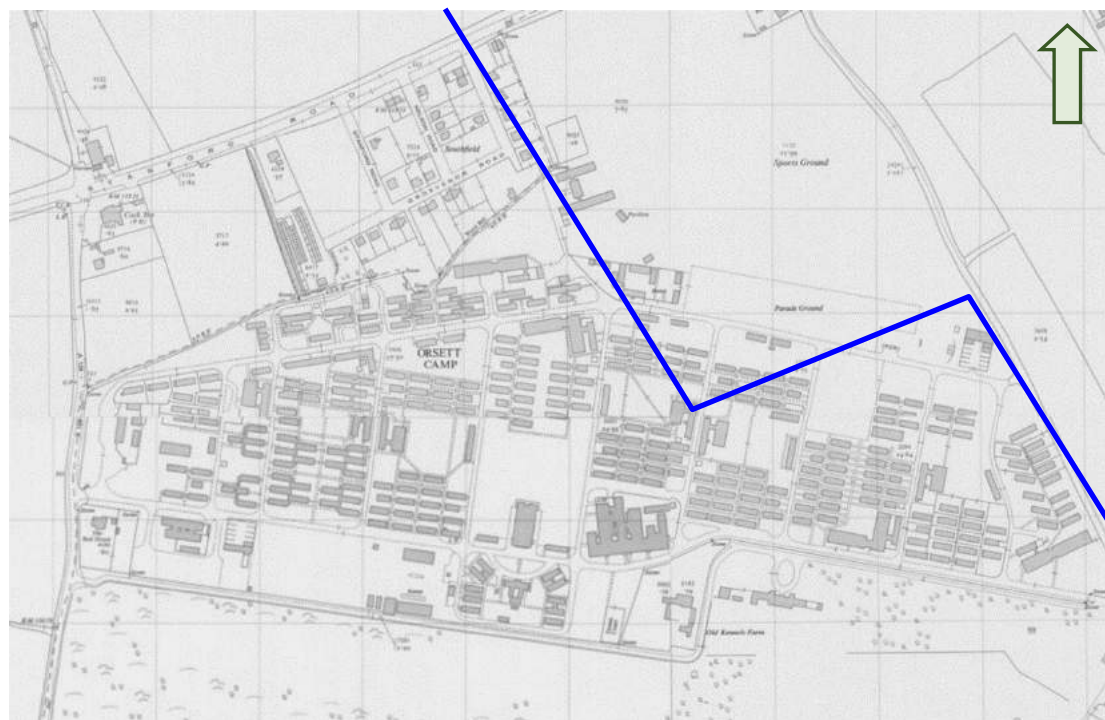
The camp remained largely unchanged during this time, as is shown in Figure 10, the historical map of 1960.

Figure 10 Historical map of 1960 showing Orsett Camp

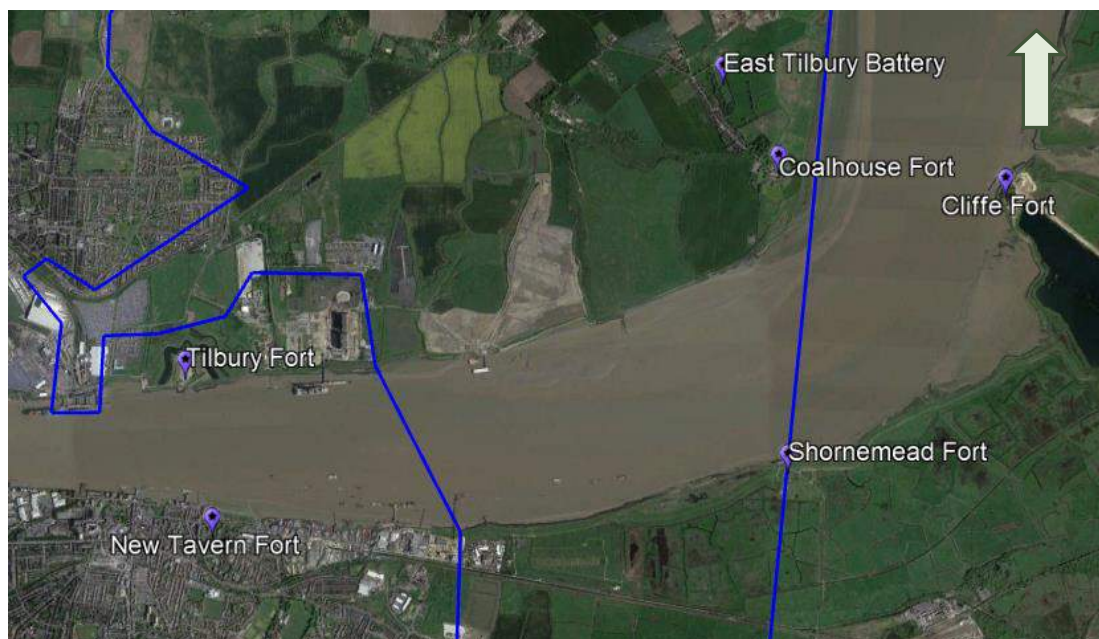
Plate 41 is an aerial photograph showing the locations of coastal batteries in the vicinity of the Site.

Plate 41 Aerial photograph showing the locations of coastal batteries in the vicinity of the Site

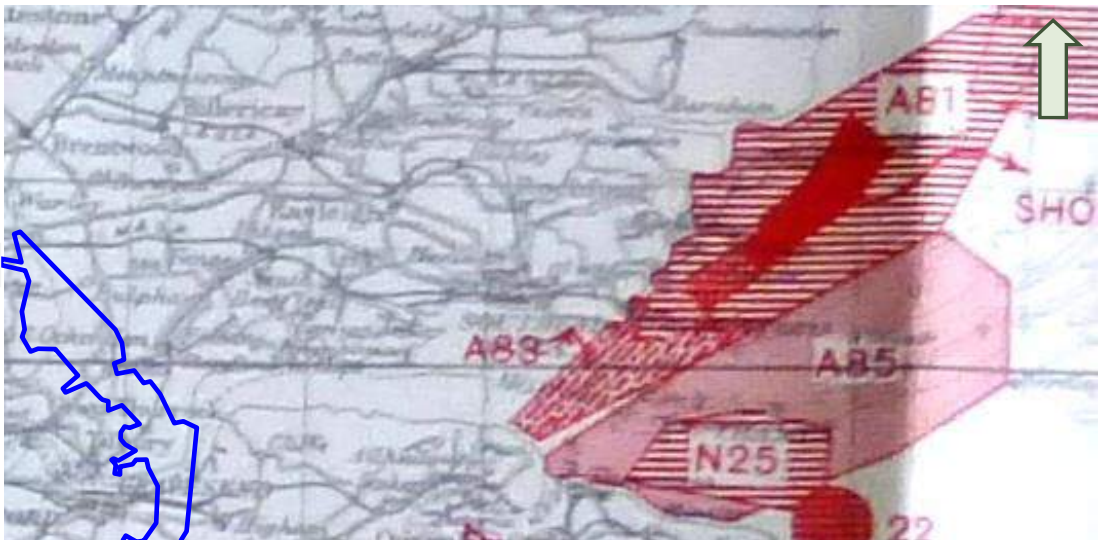
Figure 14	Extract of plan showing marine ranges in the vicinity of the Site, 1945

<p>Source: National Archives</p> <p>Not to Scale</p>	
Legend	Site boundary ———
<p>Given their distance from the Site and the tidal patterns in the area, marine ranges are not considered to provide a source of UXO hazard to the Site.</p>	
<h3>10.3 Marine Mines</h3> <p>During WWI, approximately 128,000No. mines were laid in the sea around the coast of the UK. At the beginning of WWII, the Admiralty ordered the laying of further extensive minefields around the coast of England. This included both defensive mines on beaches in order to prevent enemy landings, as well as approximately 100,000No. marine mines laid at sea to destroy enemy ships.</p> <p>Known marine minefields were cleared at the end of WWII using the original layout plans, although less than 30% of the total number of sea mines were cleared as many were moved from their original positions by tidal currents. As a result there is a possibility that some remain in the marine environment and a mine can be washed up on a beach or found drifting in the water around any part of the UK's coastline.</p> <p>Marine mines typically carried 100lbs to 500lbs (50kg to 250kg) of explosive. The initiating mechanisms in these mines have often deteriorated but the explosive charges will not have significantly altered unless the mine has split and the explosives have migrated and dispersed in the marine environment.</p> <p>No records have been found indicating that marine mines were laid on the Site.</p> <p>Records indicate that marine mines were laid in the River Thames during at least 25No. Luftwaffe raids between November 1939 and November 1941. These were effective in sinking vessels in the Thames Estuary on a number of occasions.</p> <p>Marine mines are considered unlikely to provide a source of UXO hazard to the Site.</p> <p>As with any similar area in the UK, the possibility that a buoyant mine is washed up or found drifting on the Site, albeit unlikely, cannot be totally discounted.</p>

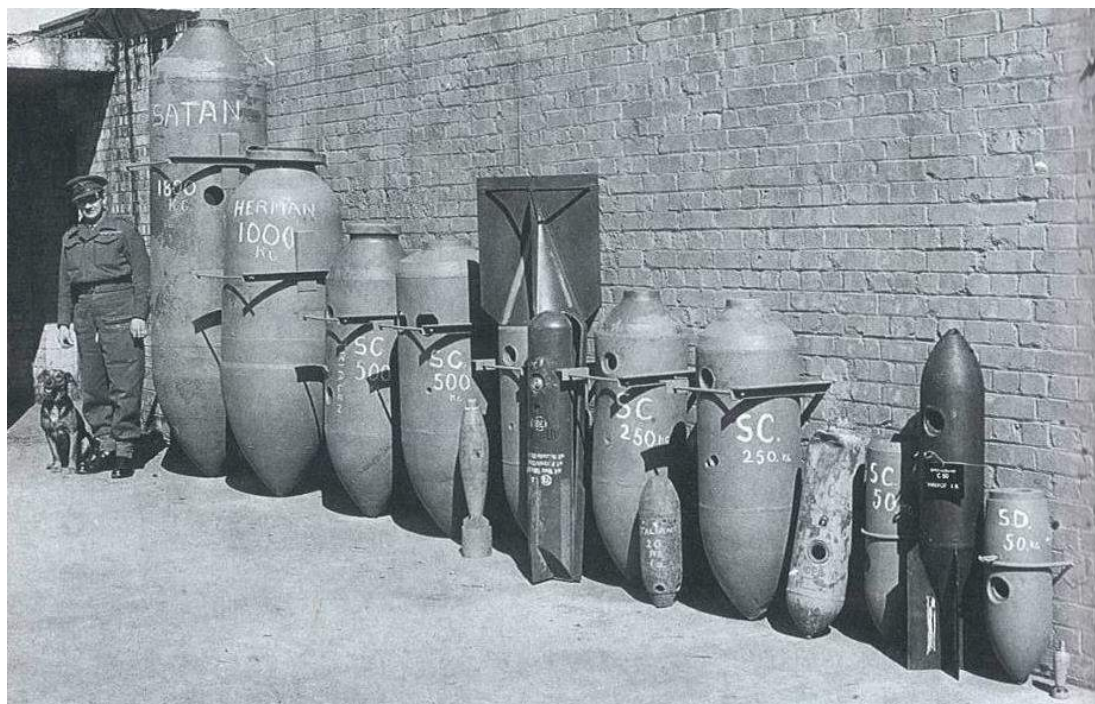
The Plate below shows the variety of UXB recovered by the Civil Defence during WWII.

Plate Photograph of a variety of UXB recovered by the Civil Defence during WWII

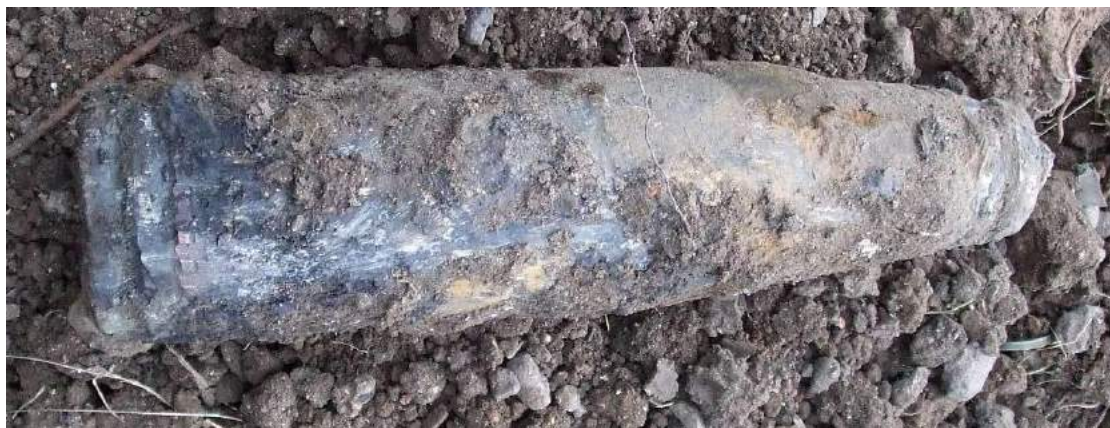
Photograph of a recently excavated 3.7" AA shell

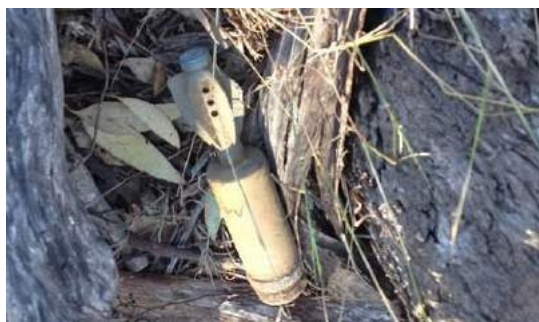
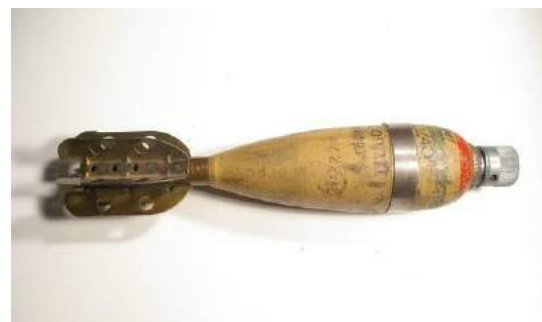
The Plate below shows a typical 2-inch mortar bomb found (left) and a demonstration 3-inch mortar bomb (right).

Plate	Photographs of WWII 2-inch and 3-inch mortars
-------	---

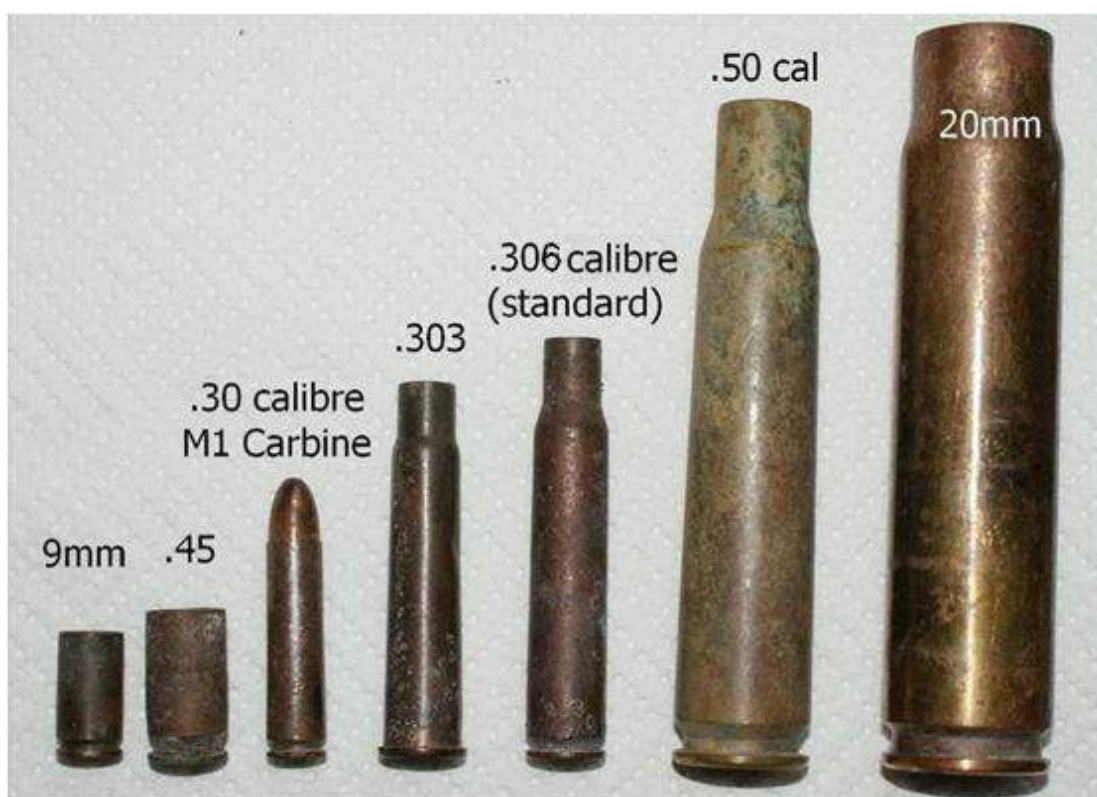
Generally small arms ordnance has a relatively low risk as UXO due to the small amount of explosive and its lack of sensitivity, although the larger calibre categories may have the same detonation risk as larger high explosive ordnance. SAA is often associated with discarded ammunition boxes around firing practice ranges. The Plate below illustrates some common SAA.

Plate Photograph of typical WWII small arms ammunition

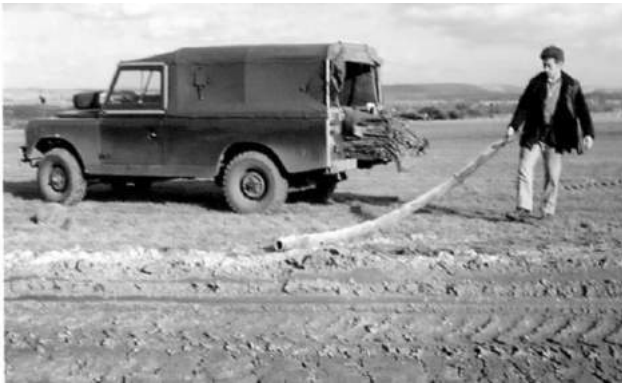
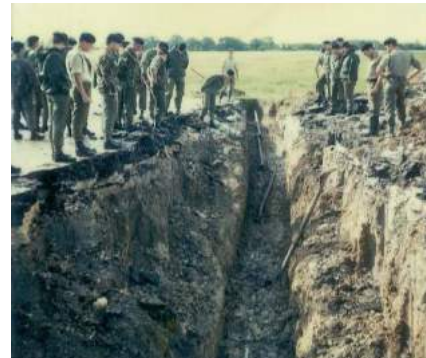
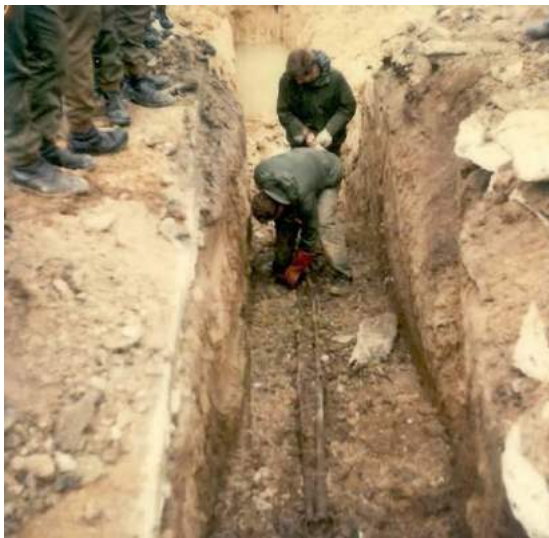
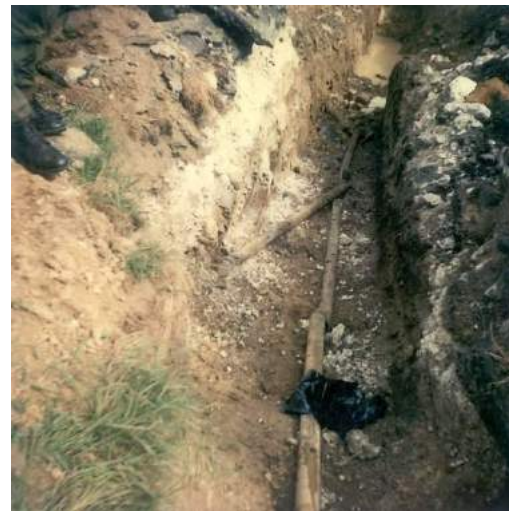
Photographs of typical pipe mines ex-situ and in-situ

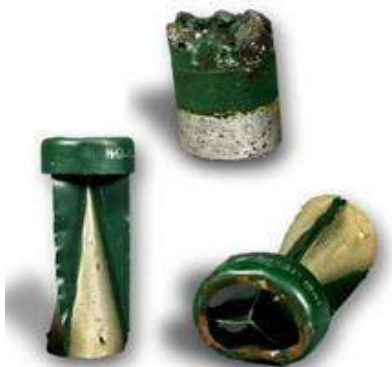
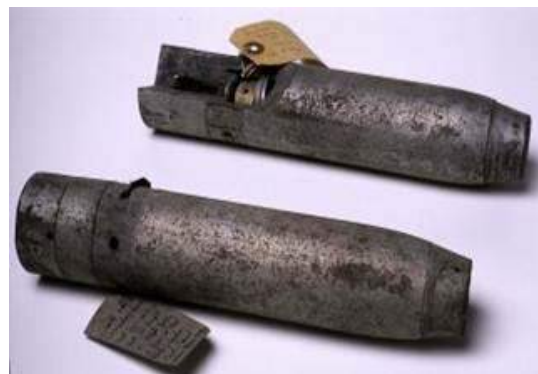
Photographs of typical fragmentary remains of IBs and a UXIB

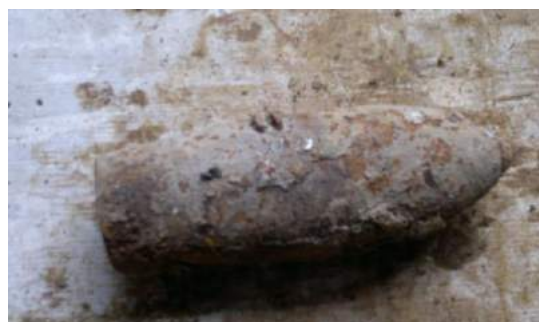
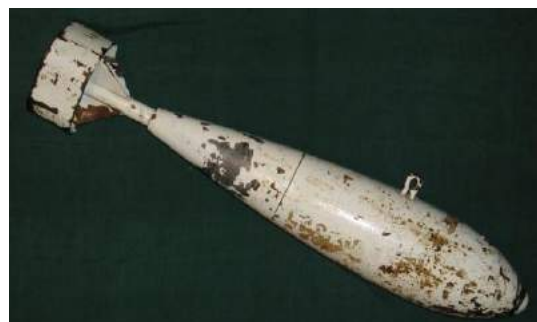
Practice bombs were typically used on inland bombing ranges. 11.5lb practice bombs contained a small explosive charge and produced a coloured powder plume for daylight operations and a light flash for night operations. The Plate below shows a recovered 25lb practice bomb head and a complete 25lb WWII practice bomb.

Plate Photographs of 25lb WWII practice bomb head and practice bomb

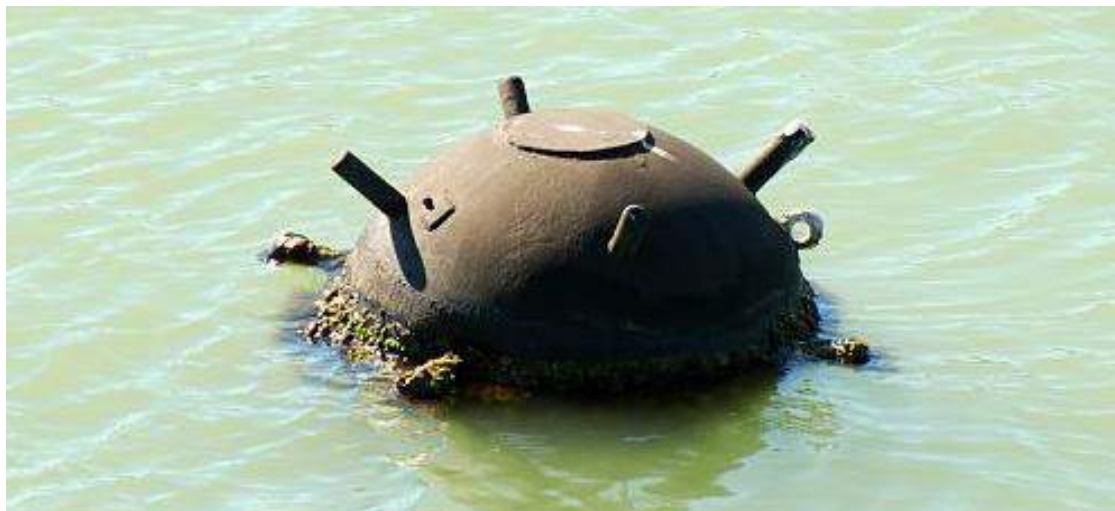
The Plate below is a photograph of a typical WWII buoyant marine mine.

Plate	Photograph of buoyant marine mine
--------------	-----------------------------------

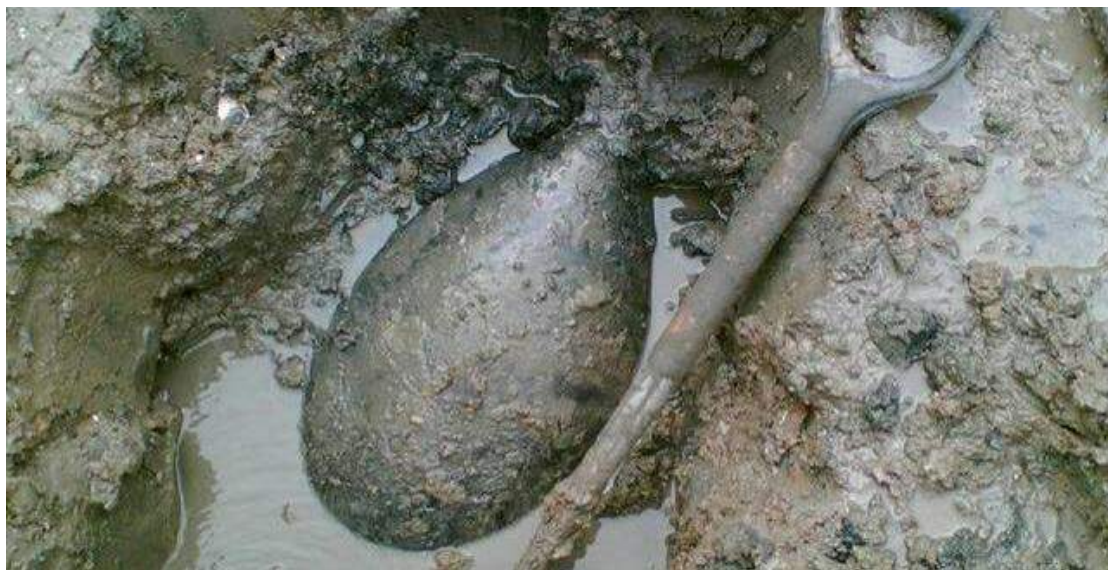
Plate	Photograph of the 500kg WWII UXB at Bowers Marsh, 8 th March 2010
--------------	--

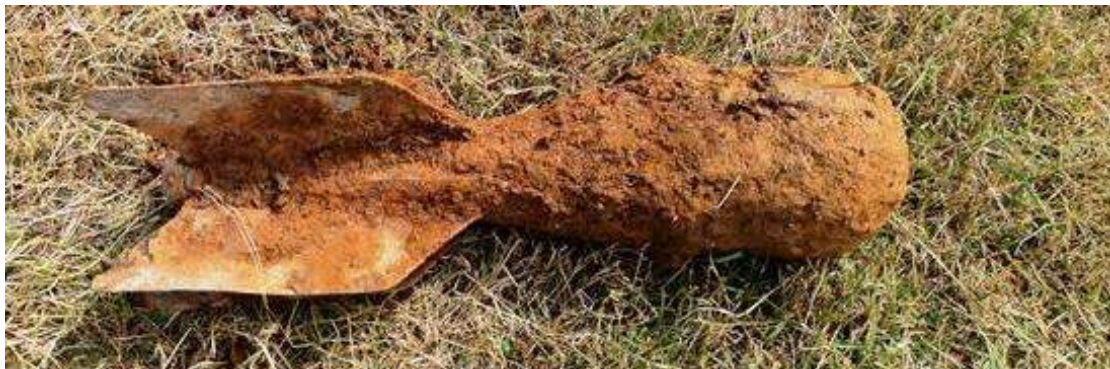
1No. WWI bomb (shown in the Plate below) was found on the Isle of Sheppey on the 2nd August 2012 during a geophysical survey following desk study research by Zetica Ltd which had established that a previously unknown WWI bombing range existed on the site. A further WWI bomb was found in the same location in August 2015.

Plate	Photograph of WWI bomb, Isle of Sheppey, 2 nd August 2012
--------------	--
